Manhole Inspection Summary

Manhole # S31G__036MH

Insp Date: **8/1/08 9:34 AM**

Location Address: **rear 400 w redwood st**

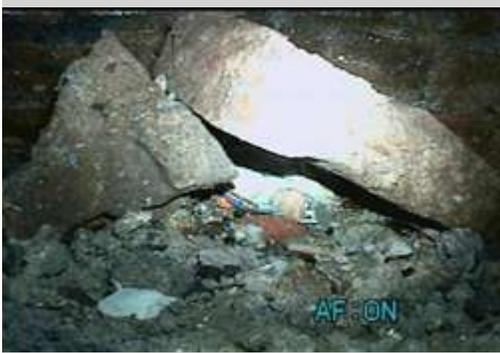
Defect 4

Condition: Sound Cracked Root Intrusion Deteriorated Leaks **Debris**

bench debris

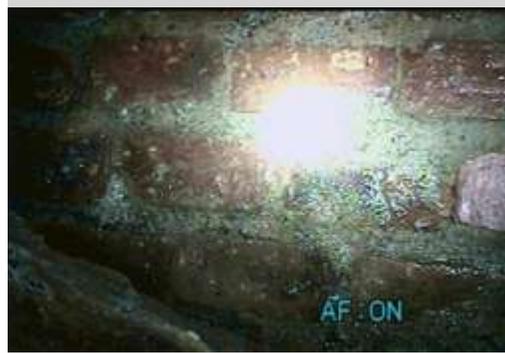
Defect 3

Infiltration: None Joint Cracks Mortar Roots **Wall**

barrel infiltration

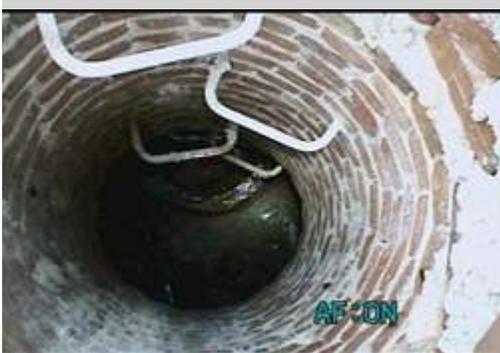
Defect 2

Steps Count: **7** Missing: **0** **Corroded**

steps

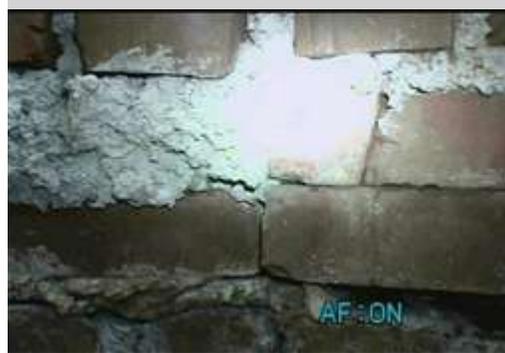
Defect 1

Condition: Sound **Cracked** Root Intrusion Loose Brick **Deteriorated**

chimney cracked,deteriorated,
frame adj

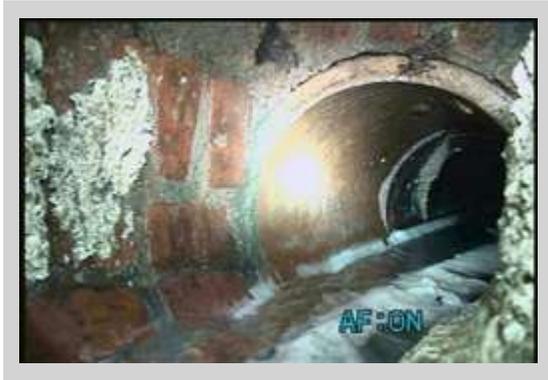
12 O'Clock Outflow

8 in. Circular Gravity Sewer
Pipe Out @ 12 O'Clock

Pipe Material: **Clay** Pipe Lined

Invert Depth: 12.00 (ft.) Flow Characteristics: **Fast**

Infiltration: **None** Pipe Seal Cond: **Unknown**

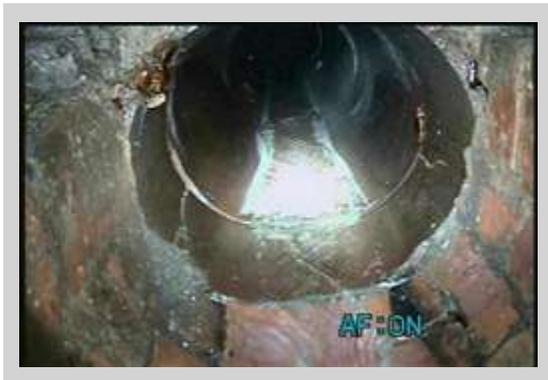
3 O'Clock Inflow

8 in. Circular Gravity Sewer
Pipe In @ 3 O'Clock

Pipe Material: **Clay** Pipe Lined

Invert Depth: 11.90 (ft.) Flow Characteristics: **Fast**

Infiltration: **None** Pipe Seal Cond: **Unknown**
